INPO 11-005  
November 2011

# **Special Report on the Nuclear Accident at the Fukushima Daiichi Nuclear Power Station**

Revision 0

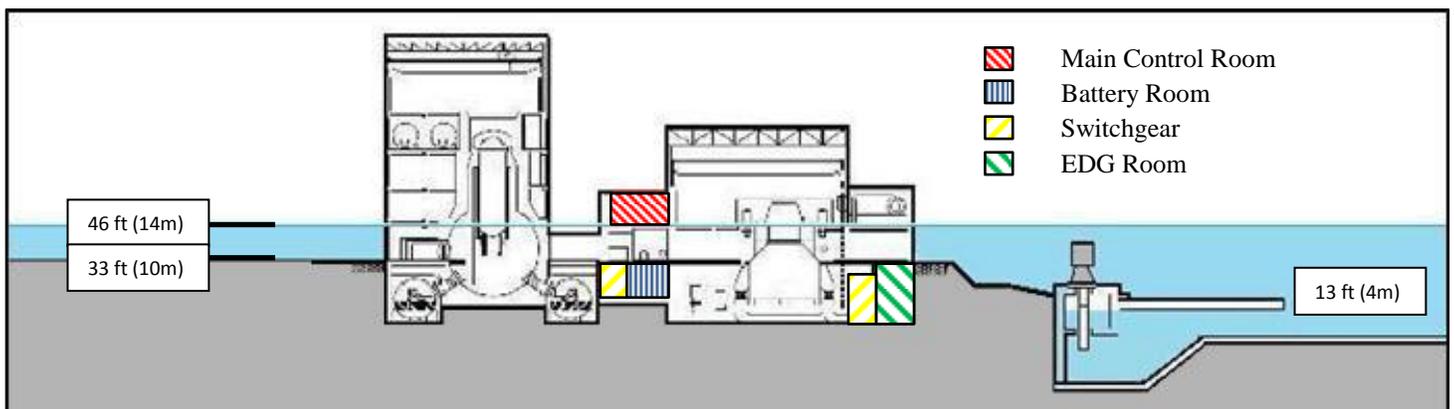
Figure 3.3-1 General Elevations and Inundation Level

The tsunami inundated the area surrounding units 1–4 to a depth of 13 to 16 feet above grade (4 to 5 meters), causing extensive damage to site buildings and flooding of the turbine and reactor buildings. Intake structures at all six units were unavailable because the tsunamis and debris heavily damaged the pumps, strainers, and equipment, and the flooding caused electrical faults. The damage resulted in a loss of the ultimate heat sink for all units. The diesel generators operated for a short time; but by 1541, the combination of a loss of cooling water, flooding of electrical switchgear, and flooding of some of the diesel generator rooms (located in the basement of the turbine buildings and not designed to withstand flooding) caused a loss of all AC power on site for units 1–5. (Refer to Figure 7.4-7.)

Figure 3.3-1 shows the general elevations (typical for units 1–4) and the approximate inundation level. The grade level of units 1–4 is 32.8 feet (10 meters) and is 42.7 feet (13 meters) at units 5 and 6 above mean sea level (commonly referred to as OP, for the level in the Onahama Port). The intake structures were at an elevation of 13.1 feet (4 meters) for all units.

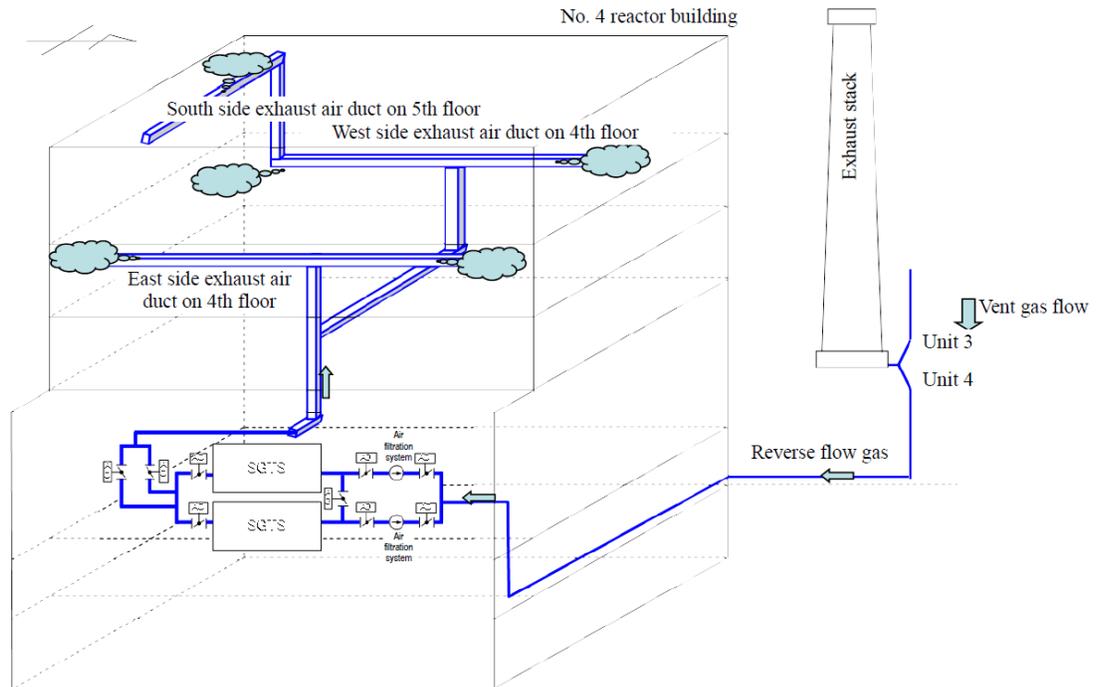
Figure 4.4-1 Unit 4 Standby Gas Treatment System Hydrogen Flow Path

The most widely accepted theory is associated with the backflow of gases from Unit 3 during venting. The containment vent exhaust piping from Unit 3 is connected to the Unit 4 exhaust piping. The dampers on the Unit 4 standby gas treatment system (SGTS) are air-operated and fail open on a loss of power or air (except the cross-connect between SGTS filter trains). Additionally, the system does not have a backflow damper installed in the piping that connects to Unit 3. With no power or air, and no fans in service to direct the gases from Unit 3 up the exhaust stack, the exhaust gases from Unit 3 would be directly aligned to the Unit 4 SGTS filters. This piping arrangement may have allowed

gases from the Unit 3 containment to be vented to the Unit 4 reactor building via reverse flow through the Unit 4 standby gas treatment system.

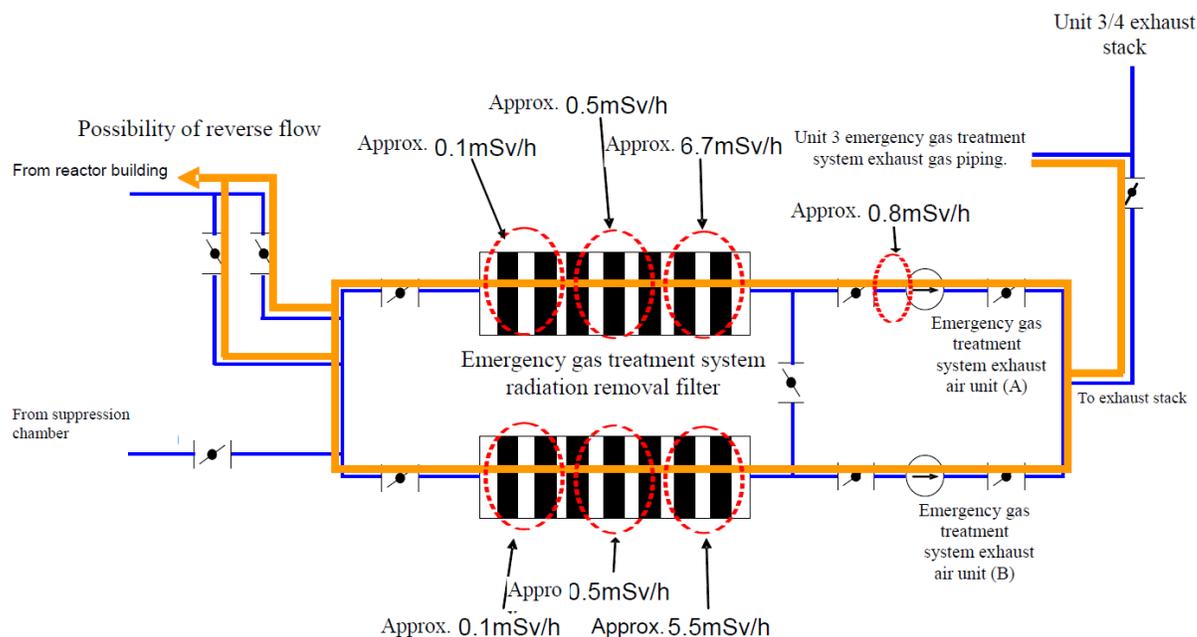
Figure 4.4-2 Unit 4 Standby Gas Treatment System Filter Survey Results

To confirm this theory, on August 25 TEPCO personnel performed radiation surveys on the Unit 4 SGTS filters. The survey results, shown in Figure 4.4-2, revealed higher radiation levels at the locations closer to Unit 3. These survey results support the conclusion that there was backflow from Unit 3 to Unit 4. Further inspections are needed to confirm this theory; but based on this information, it is postulated that the hydrogen explosion in the Unit 4 reactor building was caused by hydrogen from Unit 3.

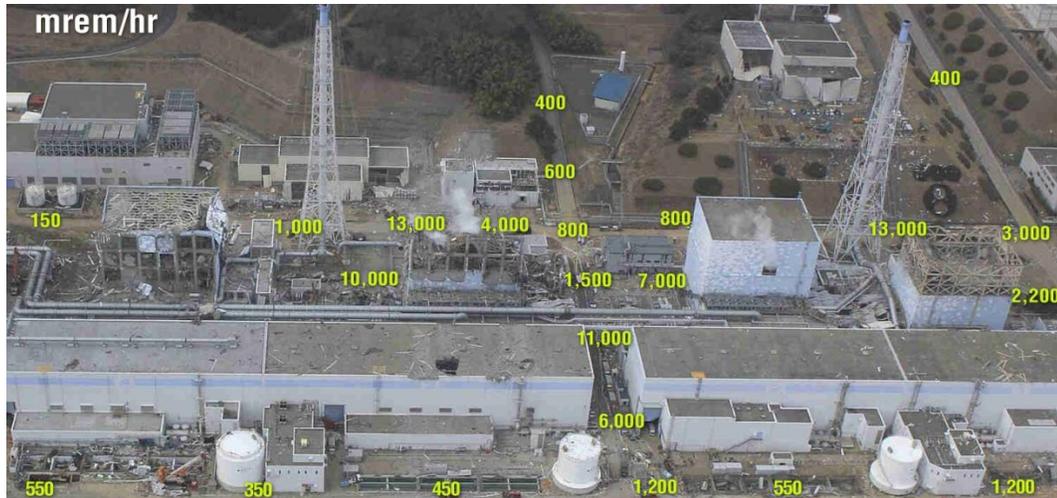
Figure 5.3-1 Site Dose Rates

On March 22 and 23, surveys of the airborne radioactivity and dose rates around the site began to be collected and documented. The dose rates are documented on Figure 5.3-1. Localized dose rates as high as 1,000 rem/hr (10 Sv/hr) were later discovered.

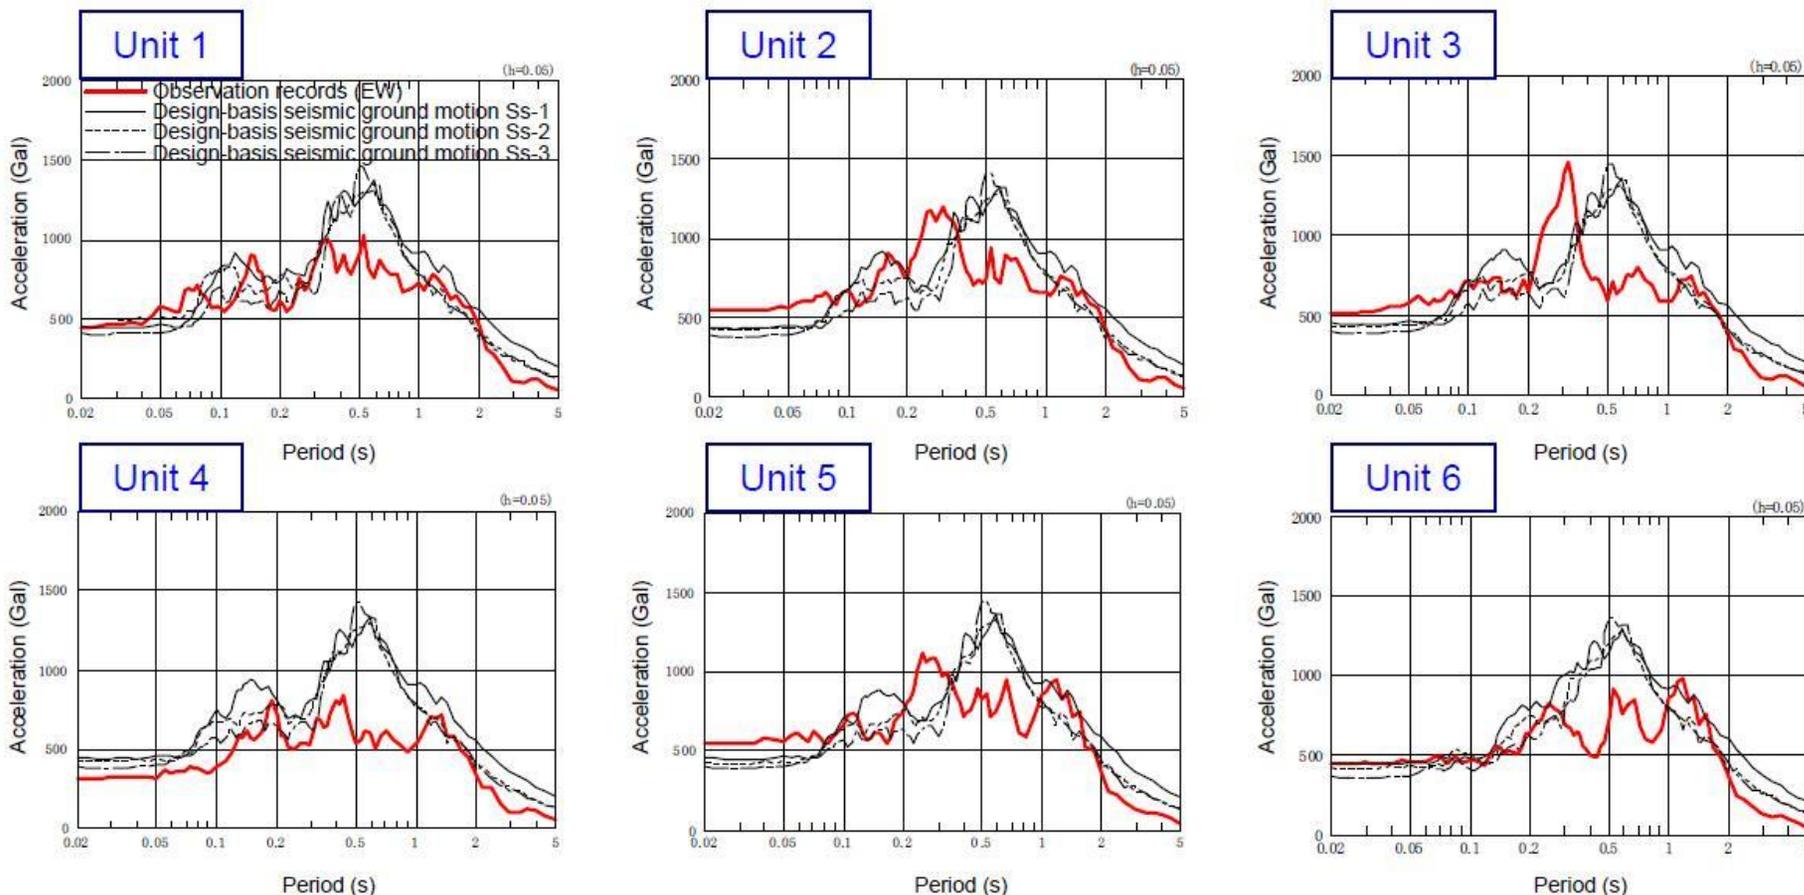
Figure 7.1-1 Preliminary Seismic Data

While no formal seismic walkdowns have been performed, a review of plant indications and operator logs does not indicate any seismic damage that affected the operator response to the earthquake. Before the tsunami, all emergency diesel generators that were operable started and loaded as expected, and each emergency core cooling system the operators used appeared to function as designed. Reactor pressure, reactor water level, and containment pressure indications for units 1, 2, and 3 appeared as expected following a scram and did not indicate any potential breach of the reactor coolant system from the earthquake.

Graphs indicate the observed values as compared to the design basis seismic criteria.

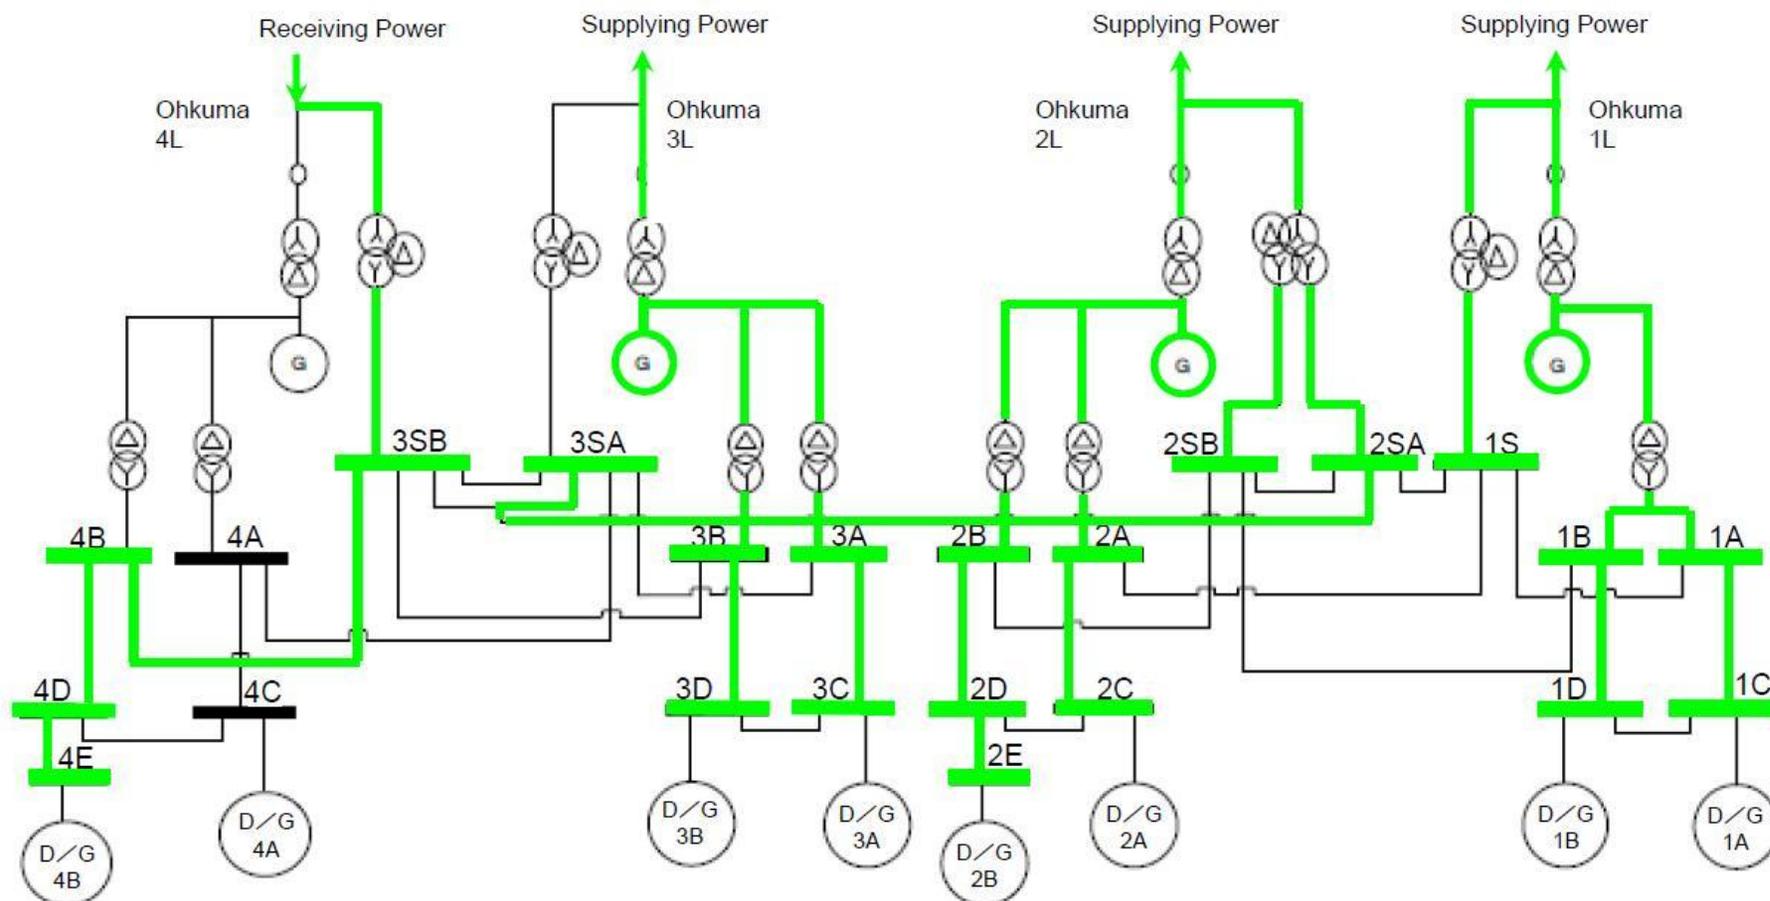
Figure 7.4-6 Simplified Electrical System<sup>11</sup>

Systems highlighted in green were in service (energized). The 4A EDG and Unit 3 startup transformer were out of service for planned maintenance at the time of the event.
