# Reactor Core Status of Fukushima Daiichi Nuclear Power Station Unit 1

May 15<sup>th</sup>, 2011

Tokyo Electric Power Company

# Provisional Analysis Result

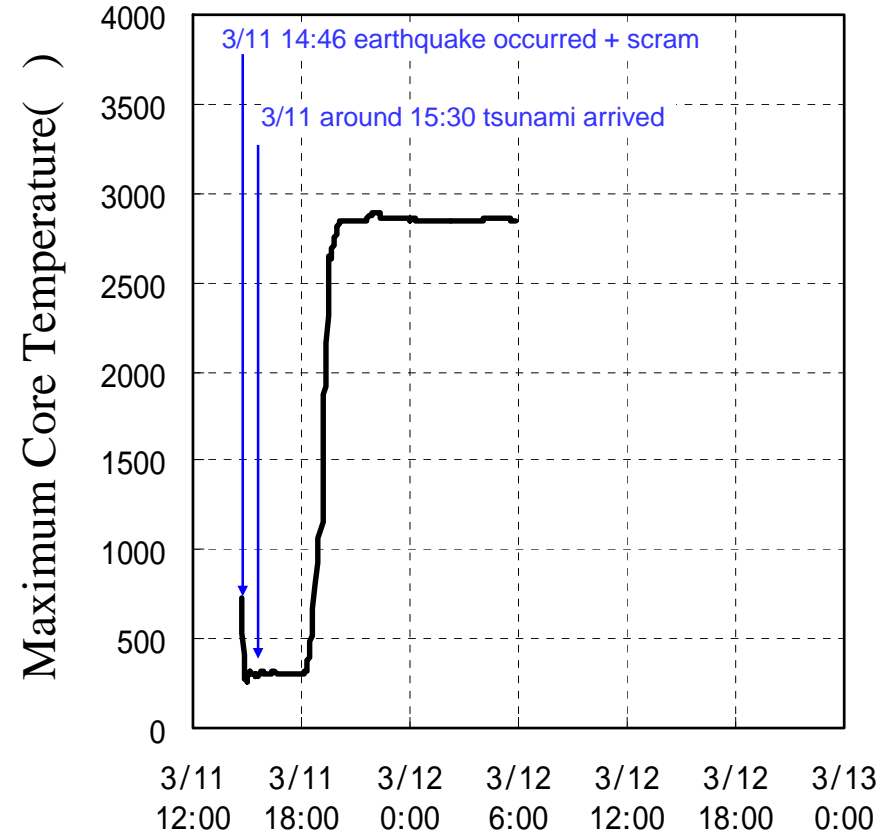
The core temperature started increasing when the reactor water level became lower than top of active fuel, then reached the core melting temperature.

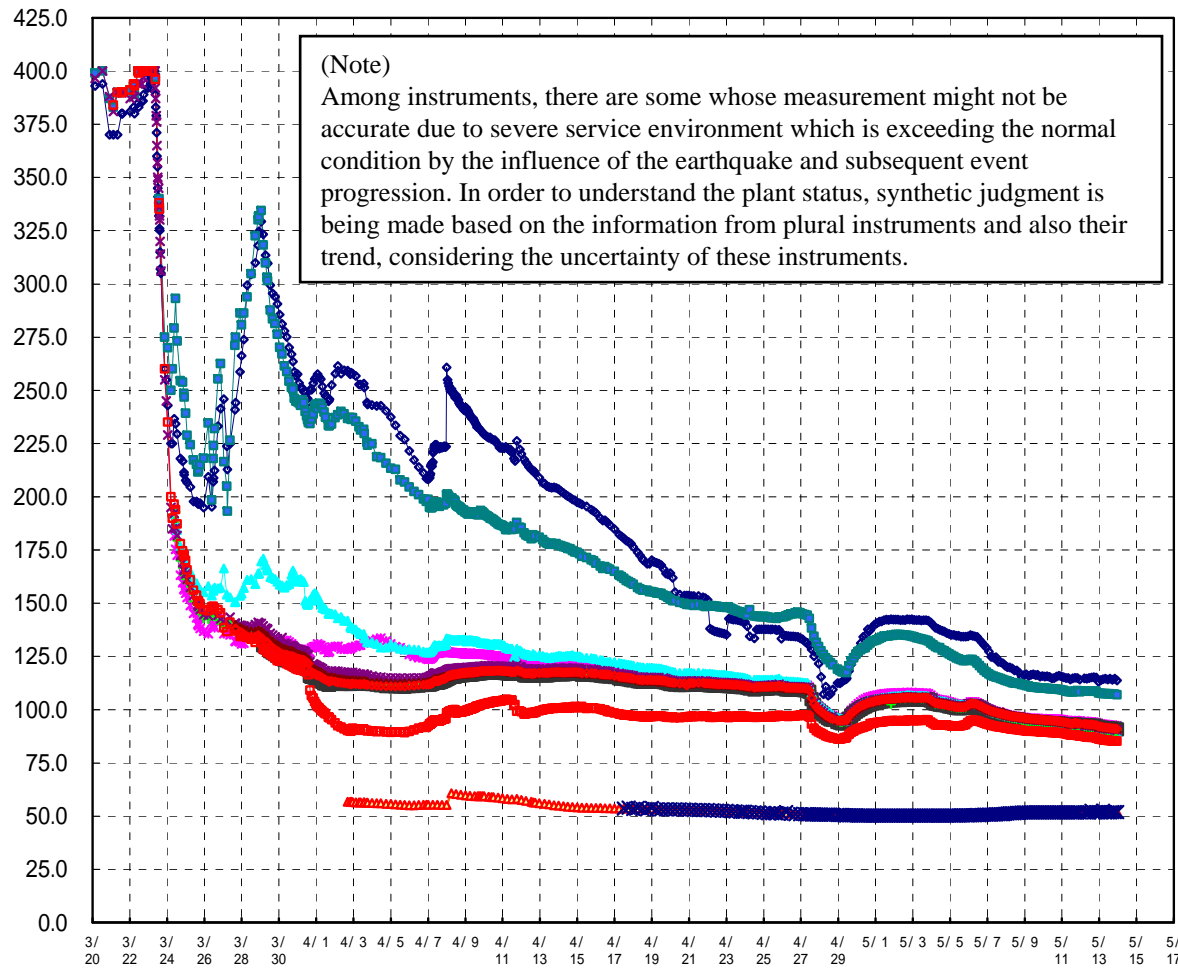
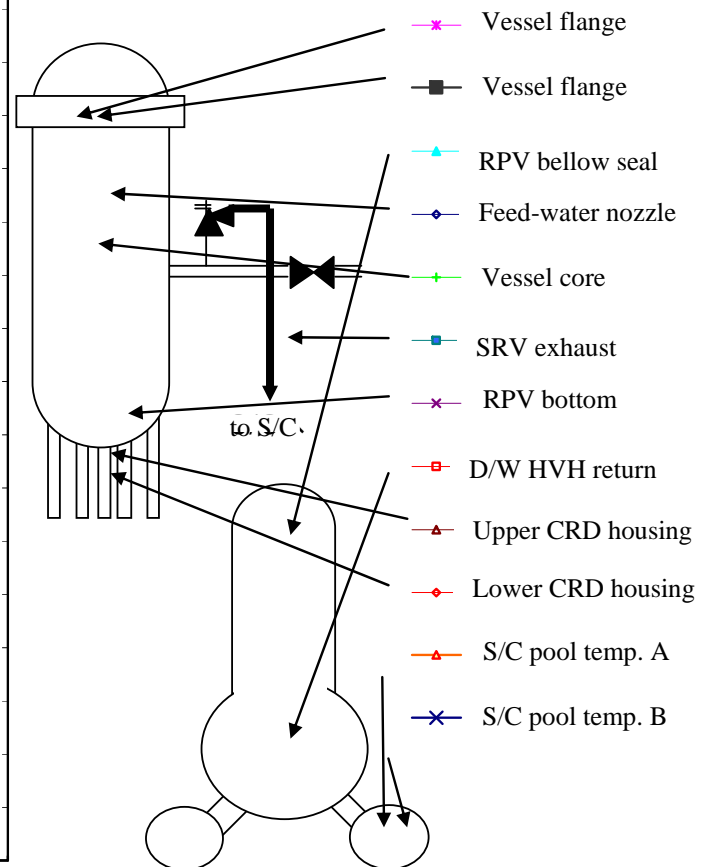
# Unit 1: Temperatures around RPV (actual measurement value)

- **The temperatures around RPV are being measured by differently-located instruments and the indications of operable instruments show a similar trend or temperatures.**

- RPV temperature is around 100 ~120 and the core is stably cooled.
  - Feedwater nozzle temperature is relatively high and this is considered to be the influence of the generated superheated steam from where some part of fuels are exposed in RPV.

- Temperatures of upper and lower part of CRD housing and also RPV bottom can be measured and they are showing a similar tend of temperature.
- **Therefore, considering the above, the fuels are considered to be sufficiently cooled inside the RPV.**
